MARINE CASUALTY REPORT

M/V JOAN LA RIE III

CAPSIZING AND SINKING
IN THE ATLANTIC OCEAN
ON 24 OCTOBER 1982
WITH MULTIPLE LOSS OF LIFE

REPORT NO. USCG-M-84-2

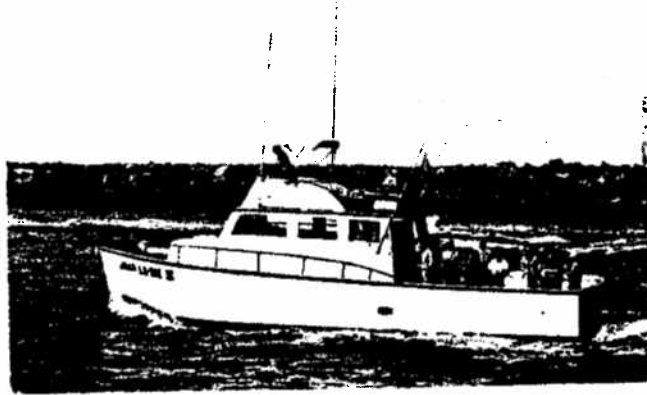
FIGURE 1 - M/V JOAN LA-RIE III OPEN FLYING BRIDGE

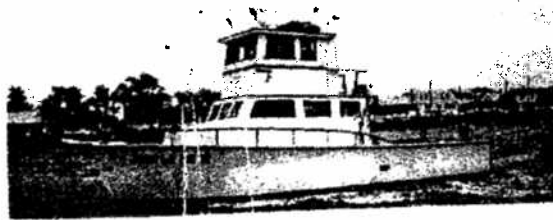
FIGURE 2 - M/V JOAN LA-RIE III AFTER FLYING BRIDGE ALTERATIONS

- a. Plywood flying bridge replaced original canvas side and open roof.
- b. Two 180 gallon fuel tanks replaced by 200 gallon capacity tanks.
- c. Portable wood fish box of approximately 200 pound capacity added to cockpit stern.

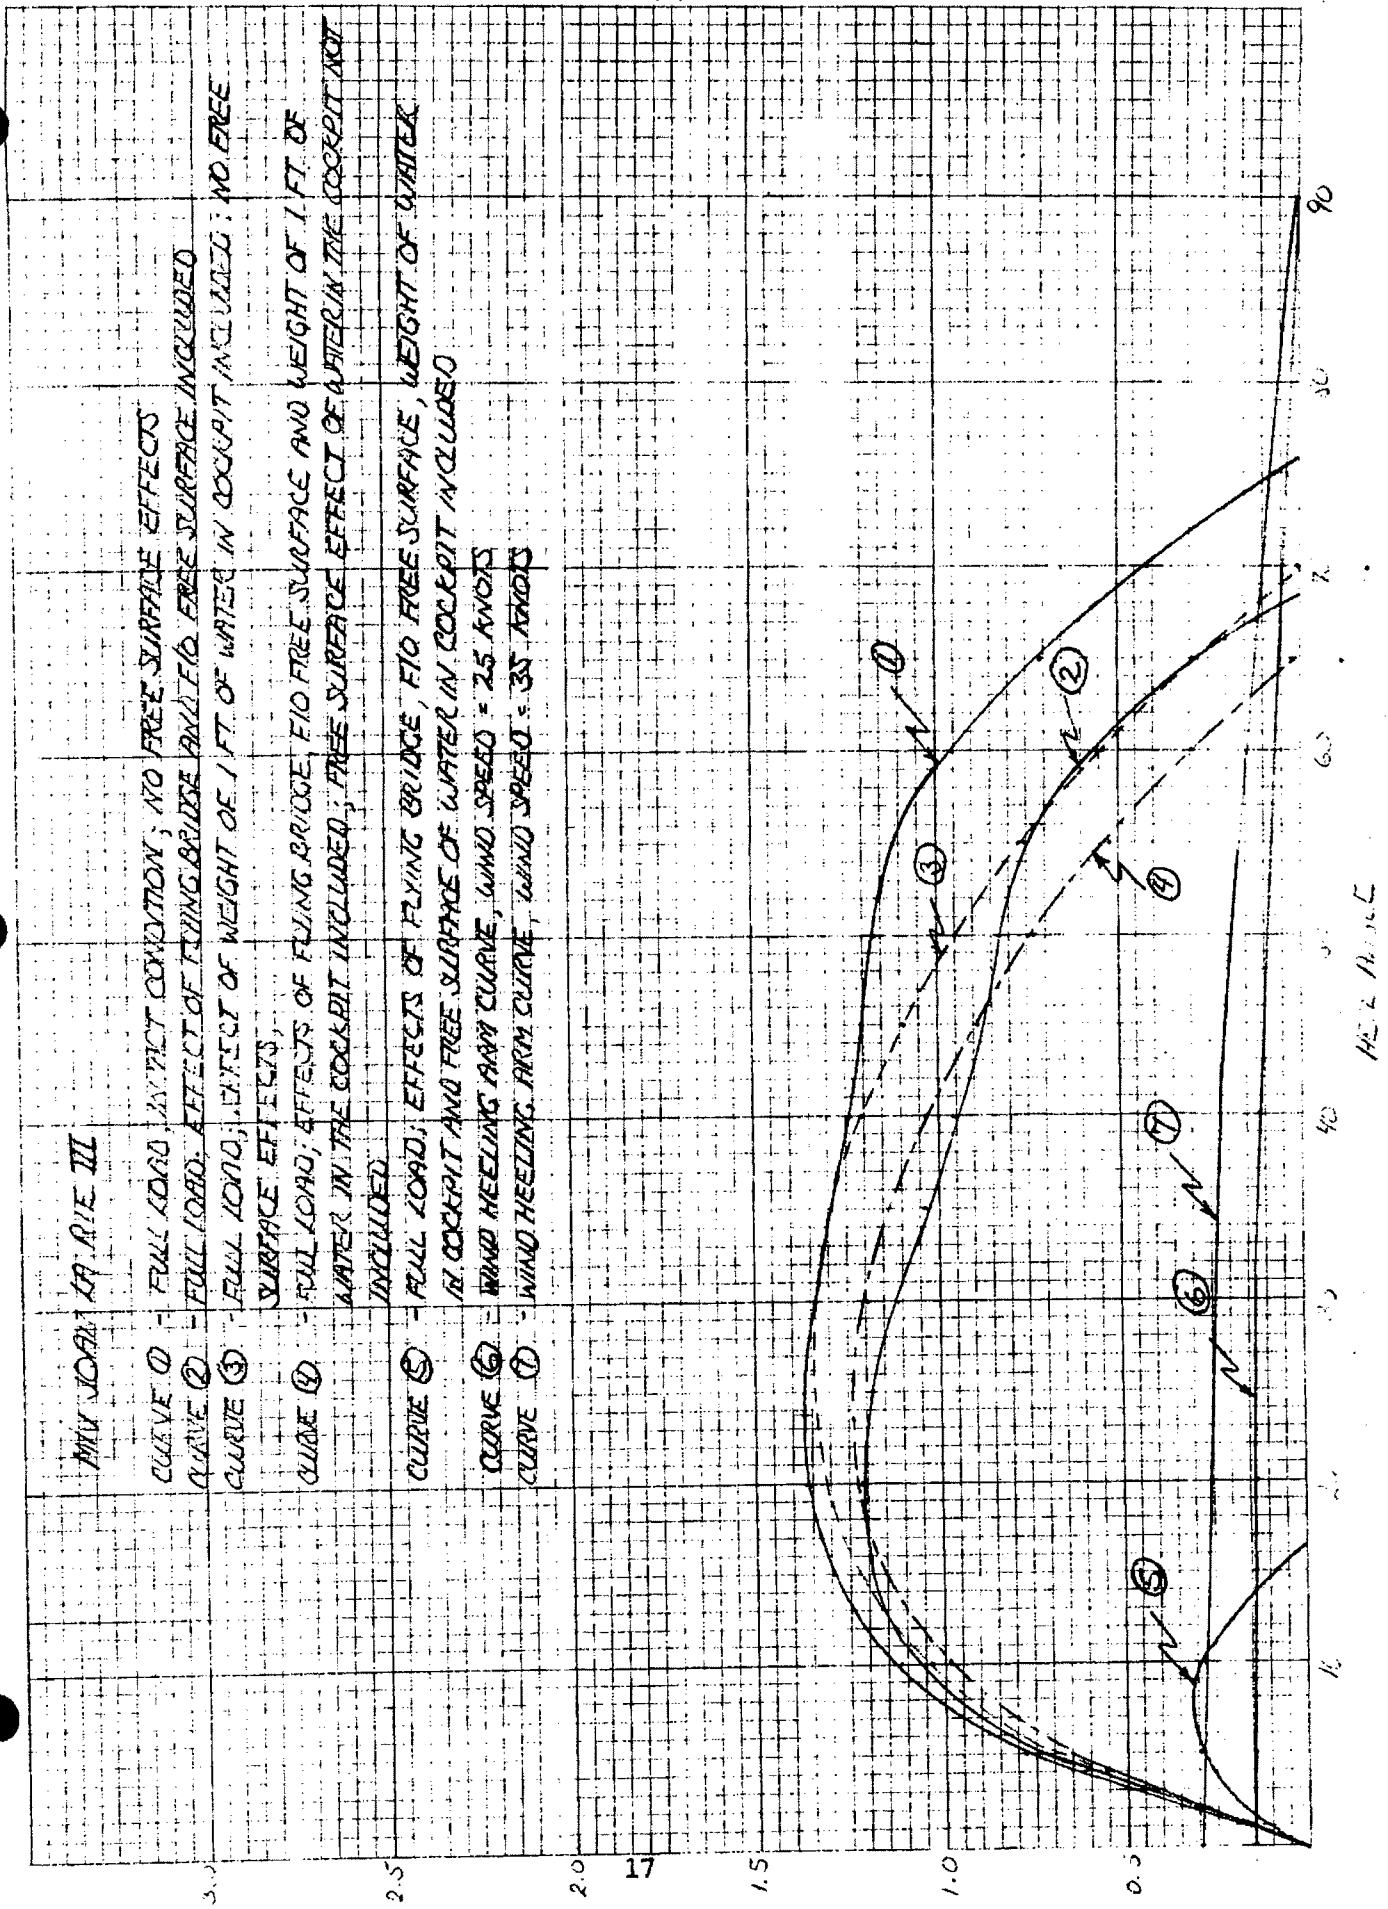
FIGURE (3)

CONDITION	ANGLE OF MAX R.A.	MAX R.A.	AREA TO ANGLE OF MAX R.A.	RANGE OF STABILITY
a.	23.6 DEG	1.37 FT	24.6 FT-DEC	76 DEG
b.	19.9 DEG	1.21 FT	19.9 FT-DEG	68.5 DEG
c.	27.4 DEG	1.35 FT	27.4 FT-DEG	70 DEG
d.	23.9 DEG	1.23 FT	22.3 FT-DEG	65 DEG
e.	4.7 DEG	0.35 FT	0.8 FT-DEG	16 DEG

The calculations show that Conditions a through d far exceed the International Maritime Organization Stability Criteria for Cargo and Passenger Vessels under 100 Meters, with the exception of the requirement for the least angle of maximum righting arm (25 degrees).

25. The analysis showed that of all factors considered, the free surface effect of water in the cockpit had the most detrimental effect on the vessel's stability. It caused a substantial reduction in the available righting energy and the range of stability (see figure 3)

5. That the regulations require all small passenger vessels undergo an initial stability test and specify what alterations would require that another stability test be performed.
